### 3\_8 SHOULDER POINTS & VECTOR OFFSET CONSTRAINTS

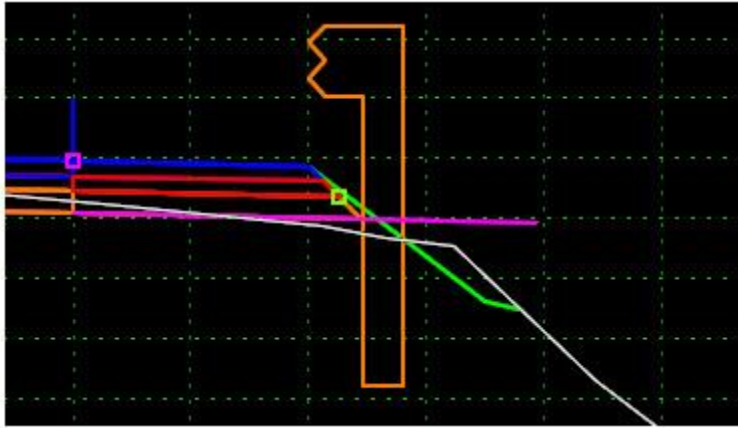
I am getting odd slopes in the areas of the shoulder point, see picture below. What is causing this problem and how do I fix it?

To remedy the problem, either move the guardrail graphic point 0.01' outside the paved shoulder point graphically or use a parametric constraint to shorten the paved shoulder width by 0.01' from the guardrail graphic point. We recommend the latter because it does not require re-importing of graphics.

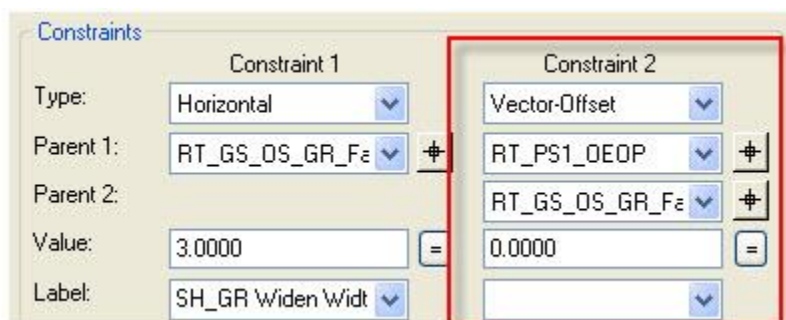
A closer look at the shoulder point reveals that "Constraint 2" has two dependent points (PS1\_OEOP and GS\_OS\_GR\_Face\_Graphics) to project the slope from and an offset distance of zero to match the slope.

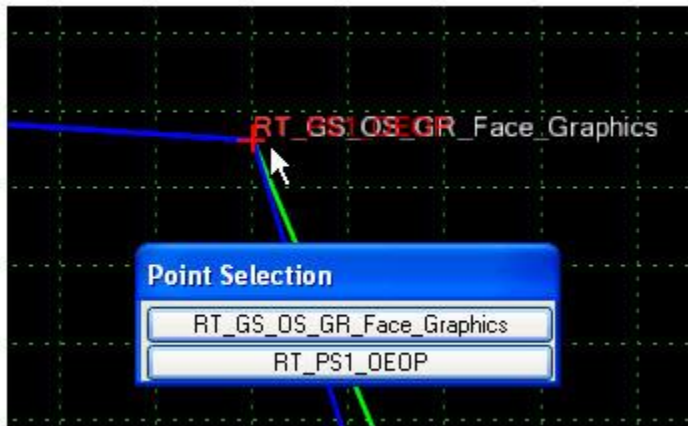
Inspecting the actual template drop reveals that these two vector points are on top of one another. Thus a projected slope cannot be computed resulting in what seems to be random "erratic" slopes.
